**RE: Asbestos Inspection and Bulk Sampling at:  
234, 236 and 240 McGill Avenue NW, Concord, NC 28025  
OSE Job #S23-1011**

One Source Environmental, LLC (OSE) was retained by The City of Concord (Client) to perform an asbestos inspection of suspect asbestos-containing materials prior to demolition at 234, 236 and 240 McGill Avenue NW in Concord, North Carolina.

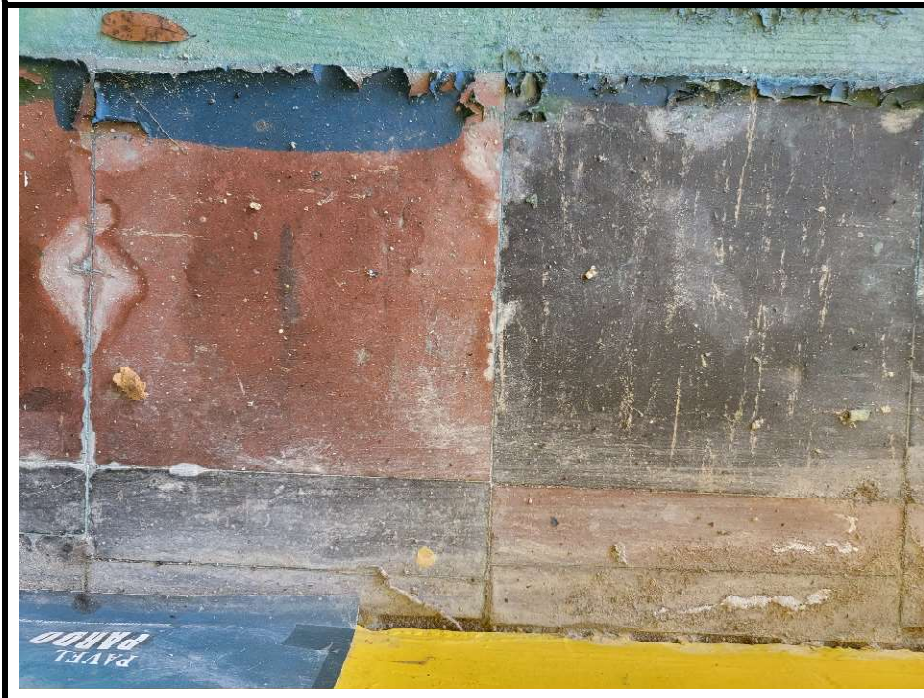
Material	Location	Percentage/ Type	Quantity	Material Condition	NESHAP Category
9"x9" Black w/ White Streaks Vinyl Floor Tile	236 Main Room	10% Chrysotile	700 SF	Sig. Damaged	CAT I NF ACM
9"x9" Red w/ White Streaks Vinyl Floor Tile	236 Main Room	10% Chrysotile	700 SF	Sig. Damaged	CAT I NF ACM

4. 236 Main Room –  
ACM 9"x9" Red with  
White Streaks Vinyl  
Floor Tile and ACM  
9"x9" Black with  
White Streaks Vinyl  
Floor Tile

Results of analysis confirmed asbestos was found to be present in concentrations greater than 1%. The materials that are, or may become friable during demolition, must be removed prior to their disturbance using OSHA Class II abatement procedures.

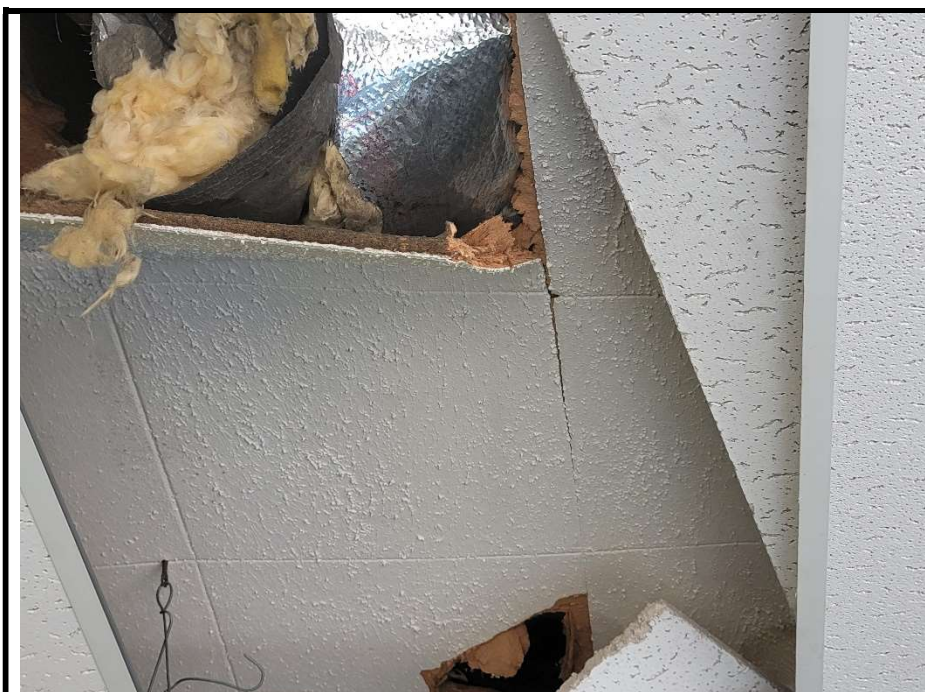
5. 236 - Non-Suspect Cellulose Ceiling Tiles with **ACM Ceiling Texture** above Non-ACM 2'x4' P'n'F Ceiling Tiles

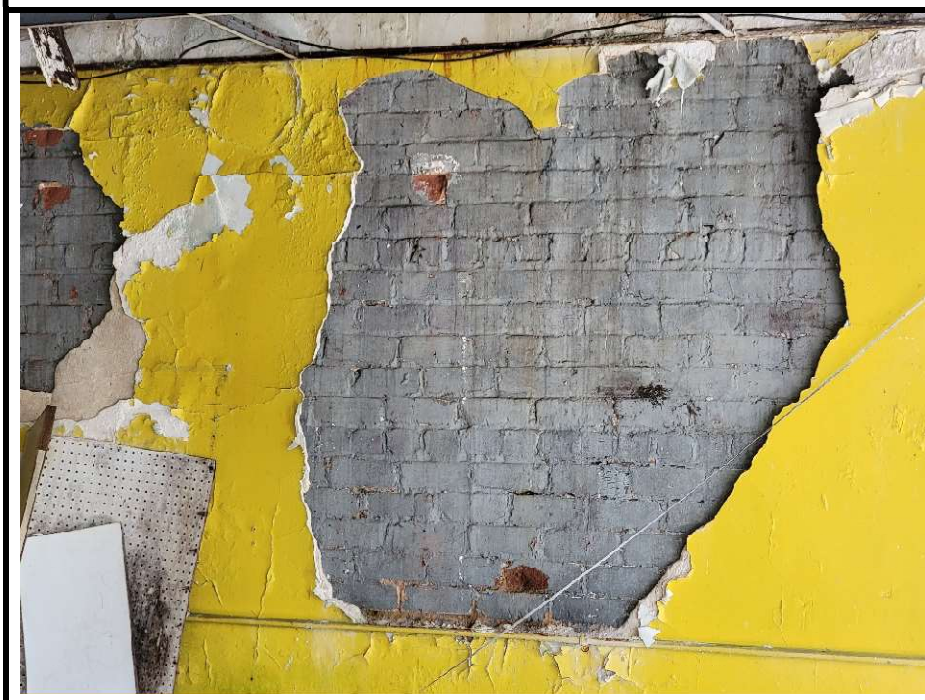
6. 236 - Non-ACM Plaster Base and Skim Coats

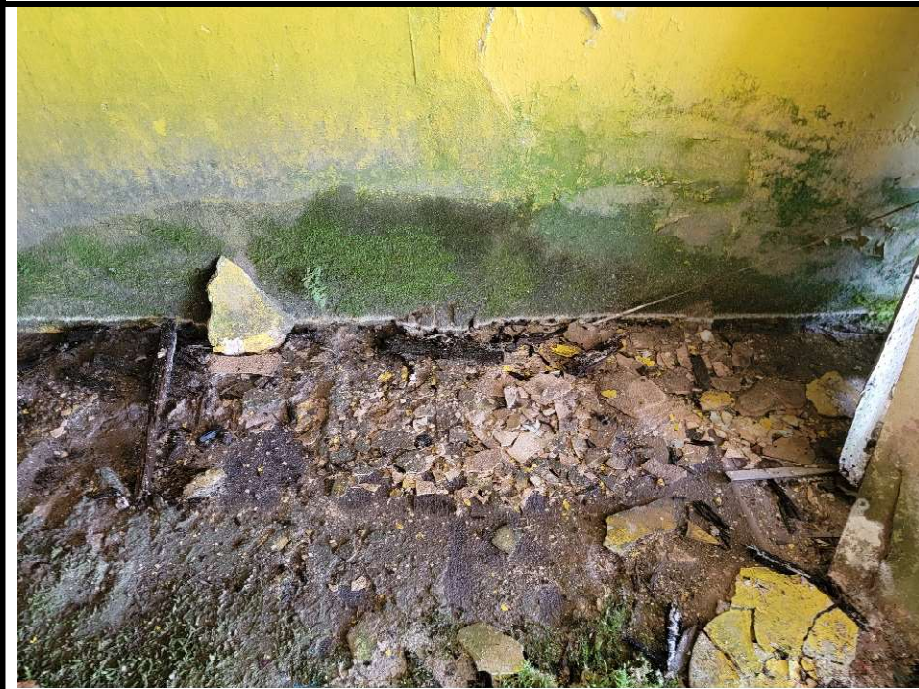
7. 236 – Sig. Damaged  
Representative  
Condition of **ACM**  
**9"x9" Vinyl Floor Tiles**

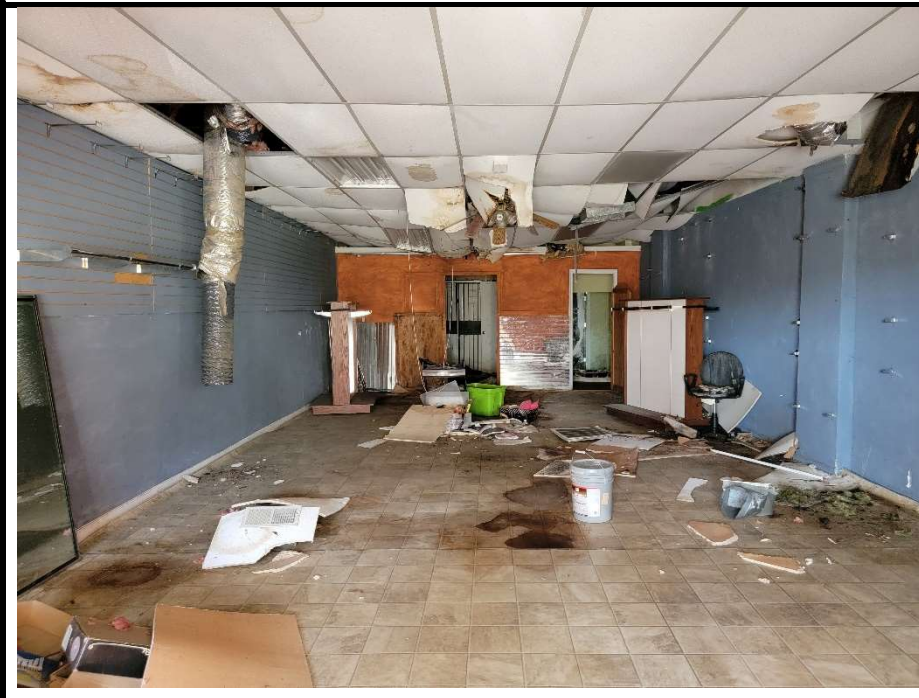
8. 240 – Middle Room  
with Non-ACM  
Drywall/Joint  
Compound and Non-  
ACM Plaster Walls

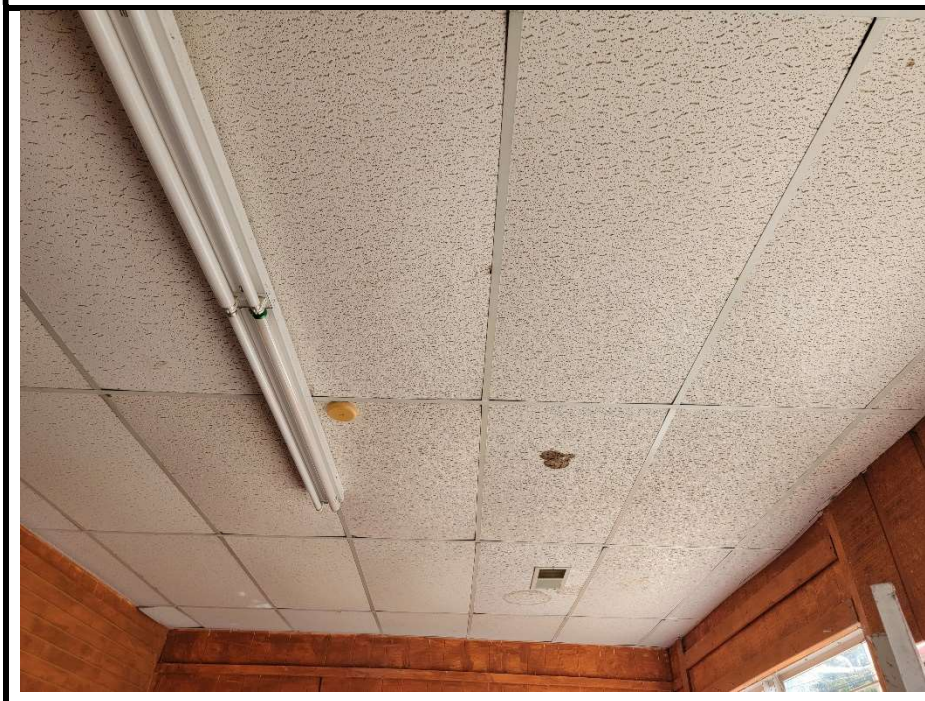
10. 240 - Non-ACM 2'x4'  
P'n'F Ceiling Tile

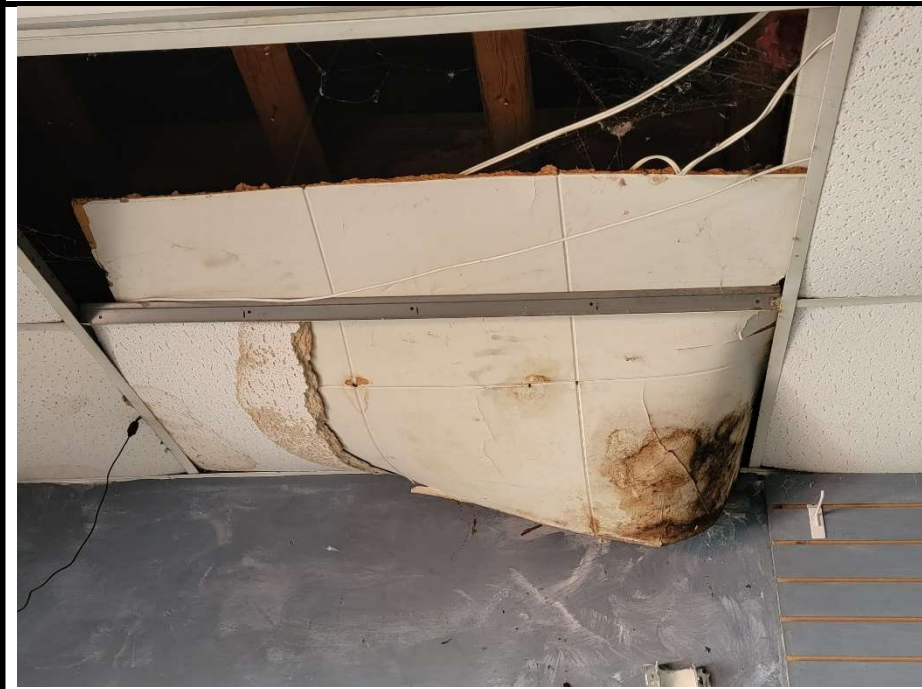
11. 240 - Non-Suspect  
Cellulose Ceiling Tiles  
above Non-ACM 2'x4'  
P'n'F Ceiling Tile

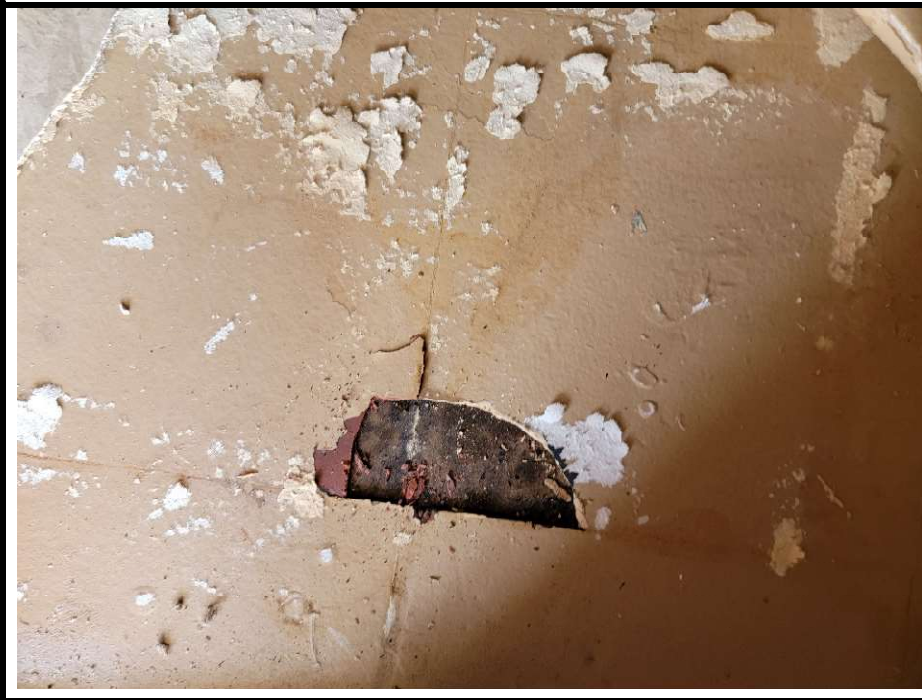
12. 240 Middle Room –  
ACM 9"x9" Red VFT  
and ACM 9"x9" Black  
VFT (both painted)  
and ACM Black Mastic  
in Middle Room  
beneath Vinyl Sheet  
Flooring

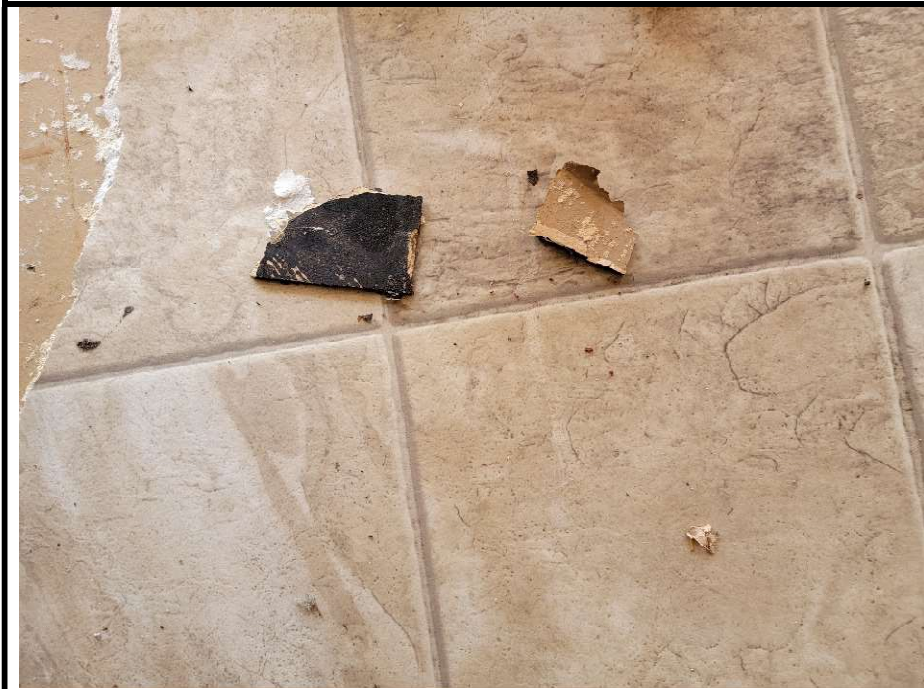
13. 240 Middle Room –  
Non-ACM Beige Vinyl  
Sheet Flooring

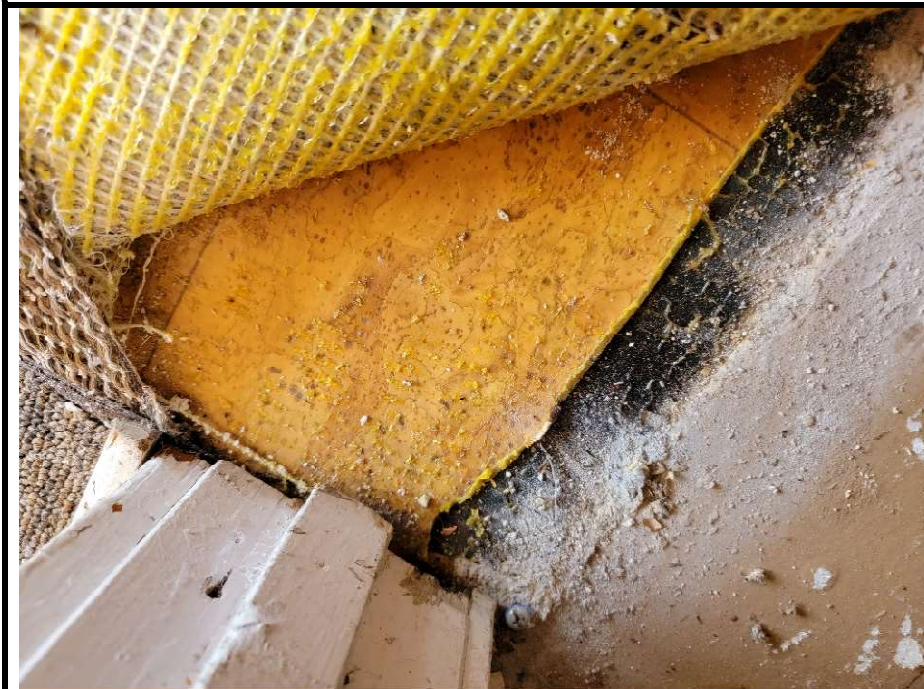
14. 240 Front Room –  
Carpet over Non-ACM  
Yellow Vinyl Sheet  
Flooring

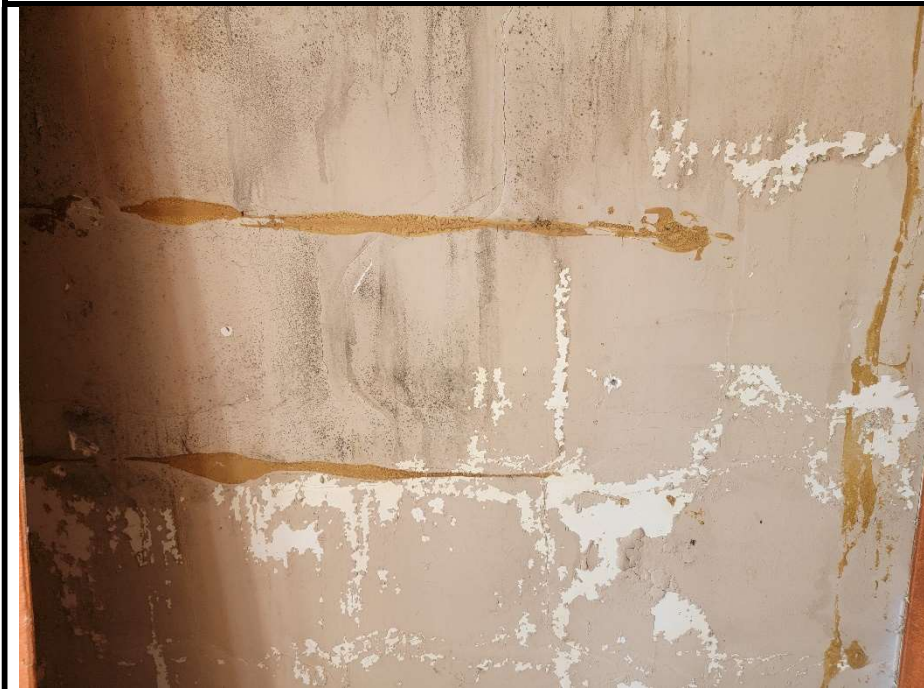
15. 240 – Non-ACM  
Paneling Glue on Wall

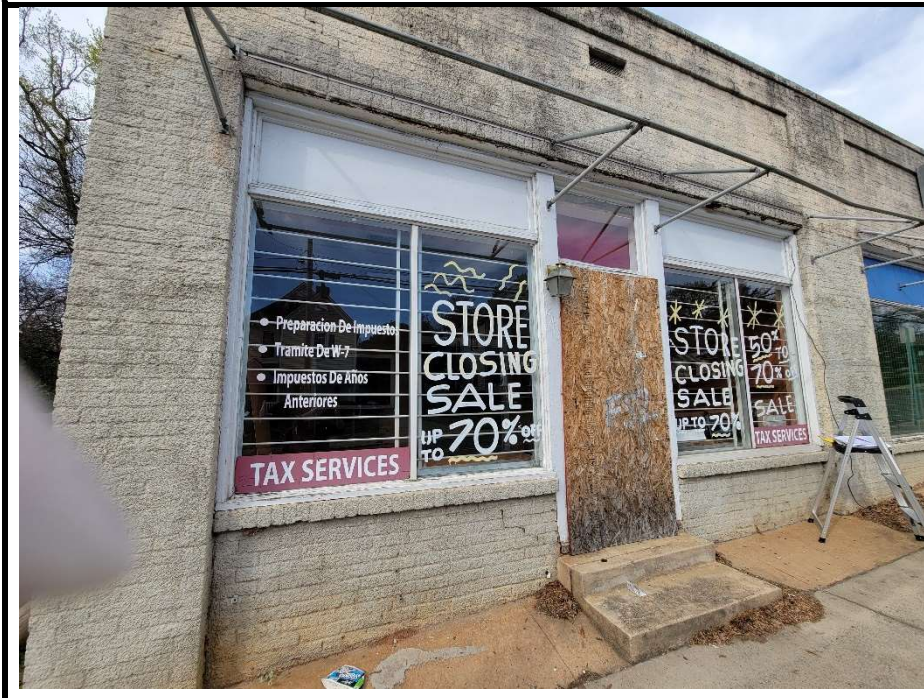
16. 240 Front Façade with  
Non-ACM Siding  
Coating

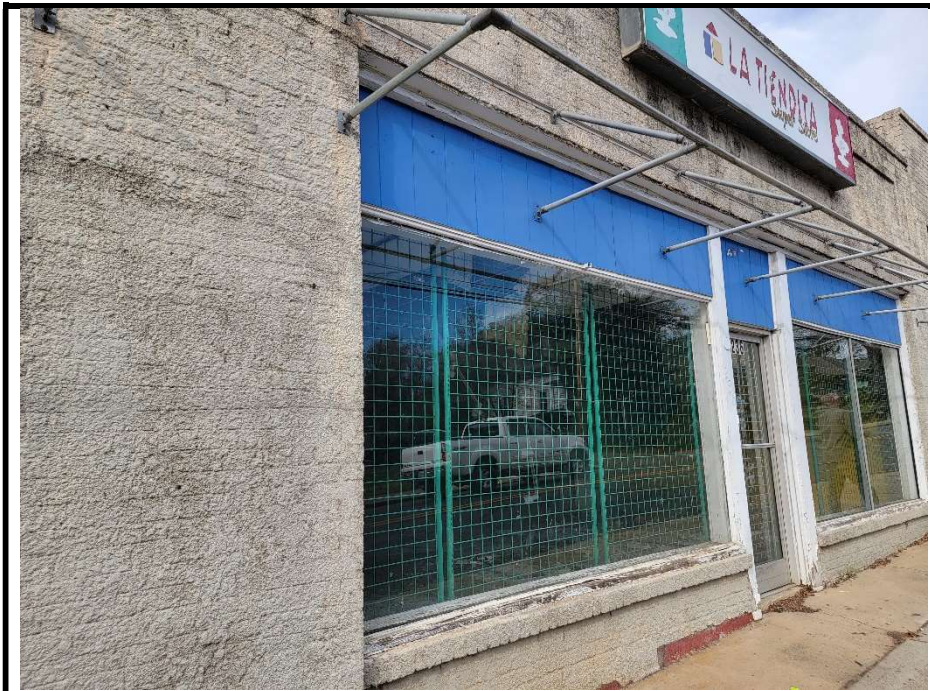
17. 236 Front Façade with  
Non-ACM Siding  
Coating

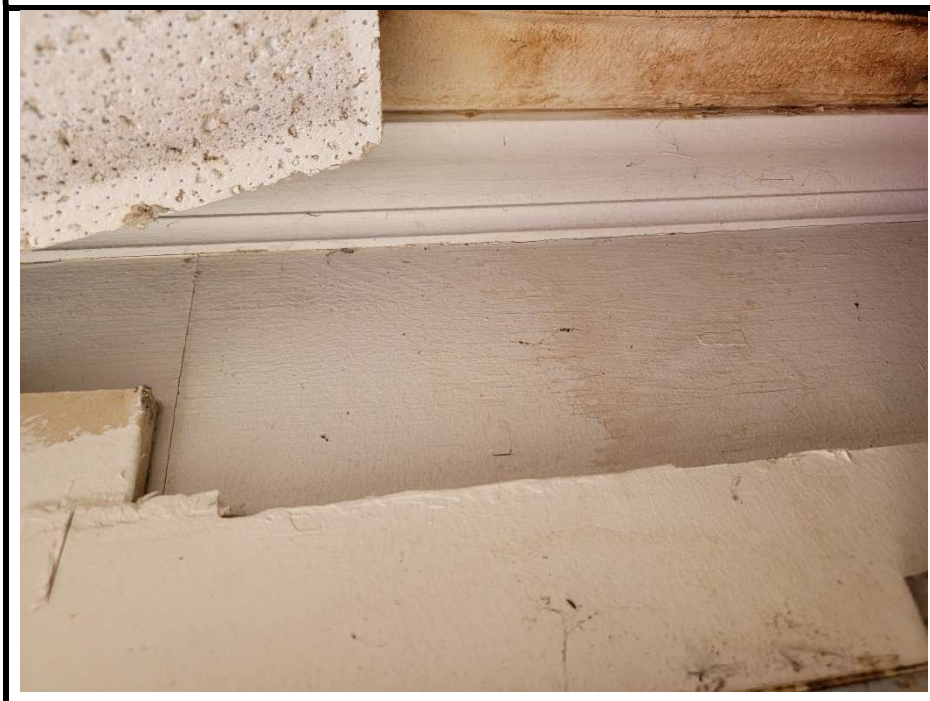
18. 234 – Non-ACM  
Plaster Wall behind  
Non-ACM  
Drywall/Joint  
Compound Walls and  
Non-ACM 2'x4' P'n'F  
Ceiling Tile

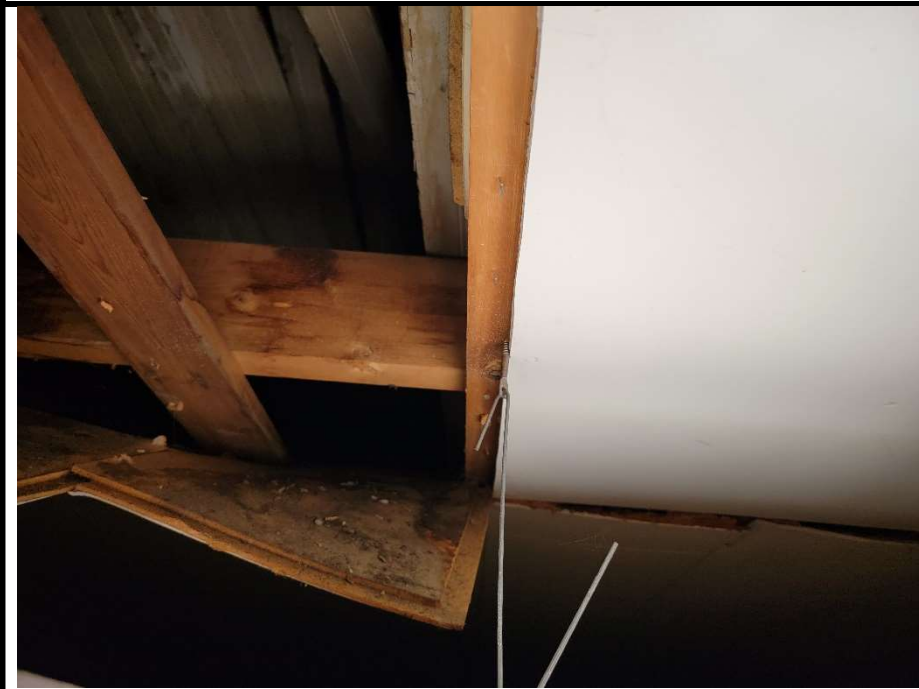
19. 234 – Non-Suspect  
Cellulose Ceiling Tiles  
found above 2'x4'  
P'n'F Ceiling Tiles

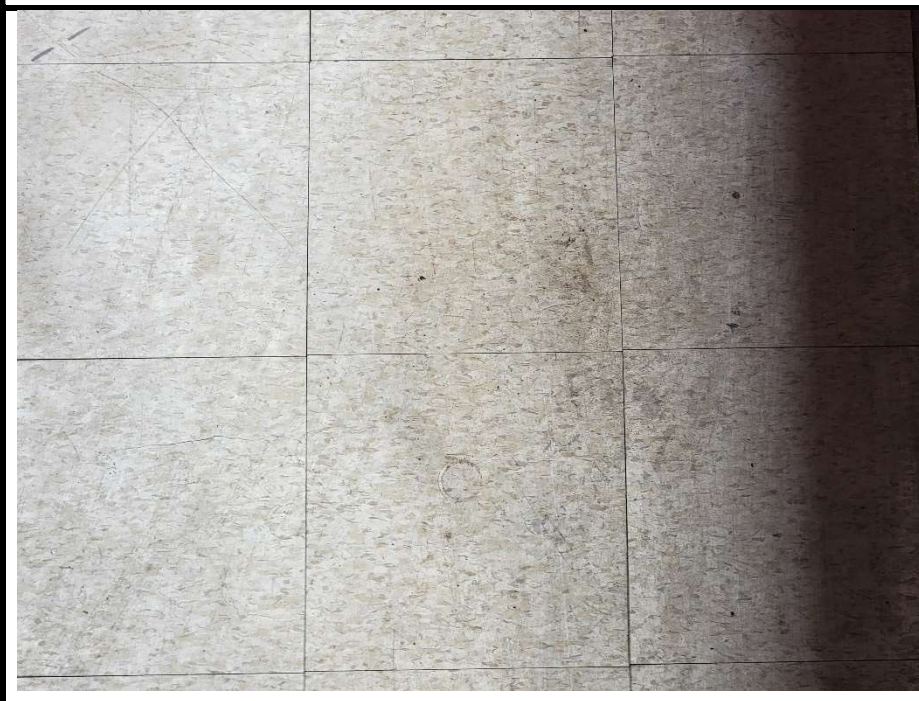
20. 234 – 12"x12" Tan  
Mottle VFT

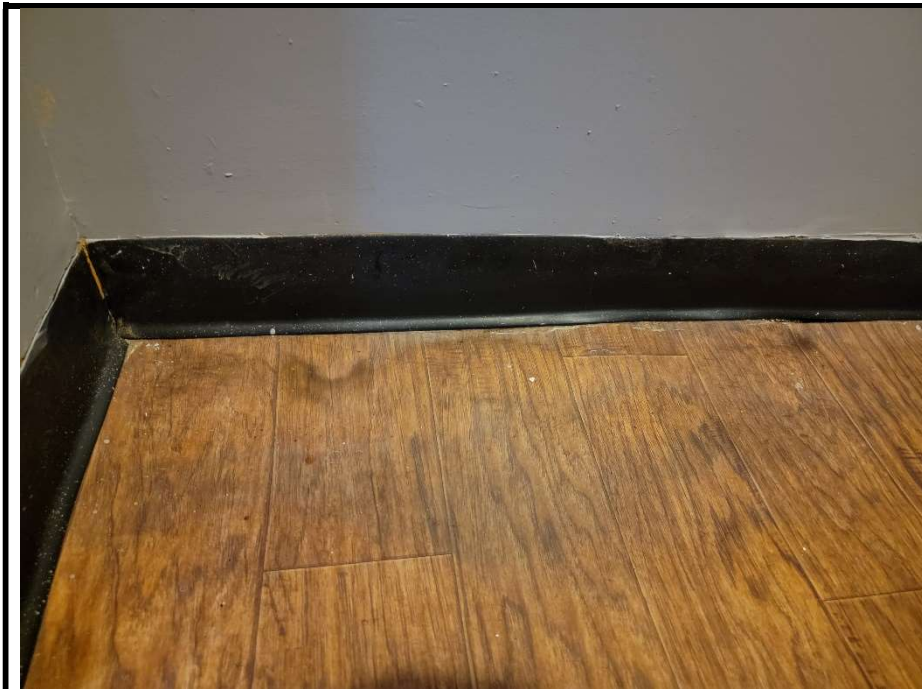
21. 234 Bathroom – Non-ACM 4" Black Cove Baseboard and Non-ACM Wood Grain Vinyl Sheet Flooring

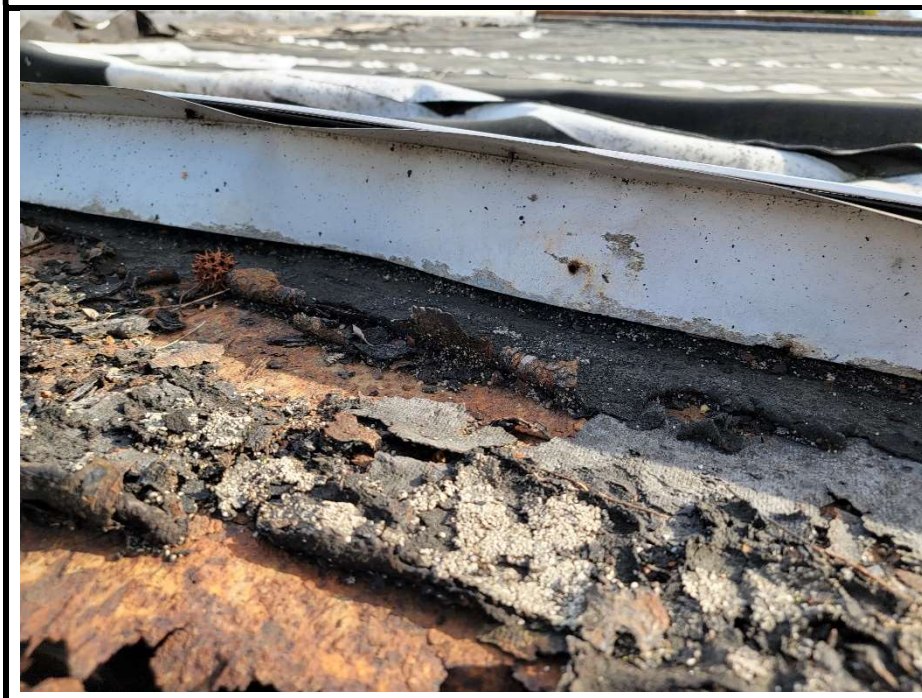
22. Roof of 236 & 240 – ACM Silver/Aluminum Paint was found in Roofing Core; remaining layers of roofing core were Non-ACM

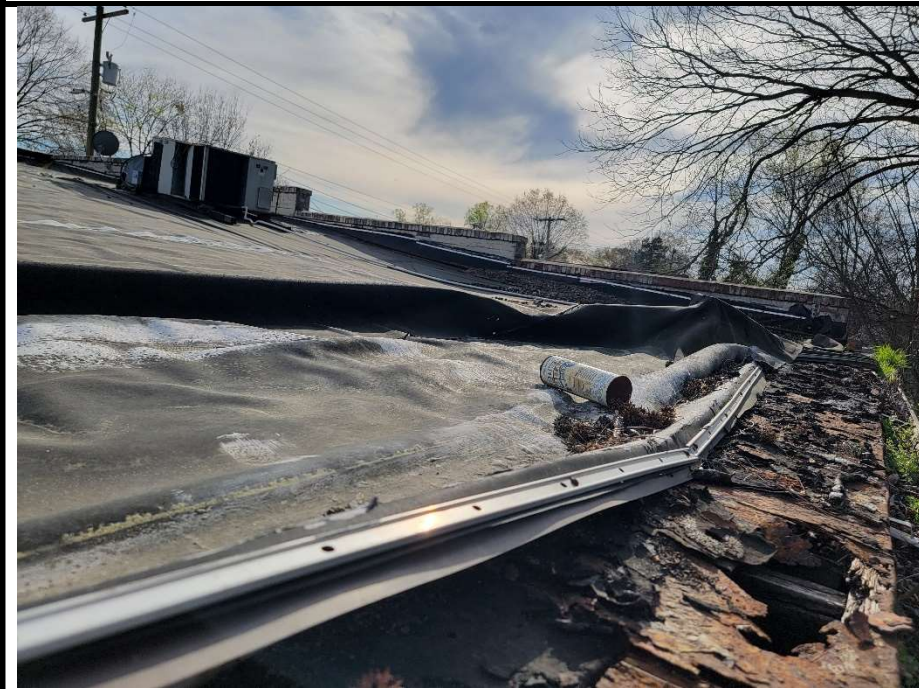
23. 236 & 240 Roof – poor condition of roof did not allow for inspector access beyond the edge

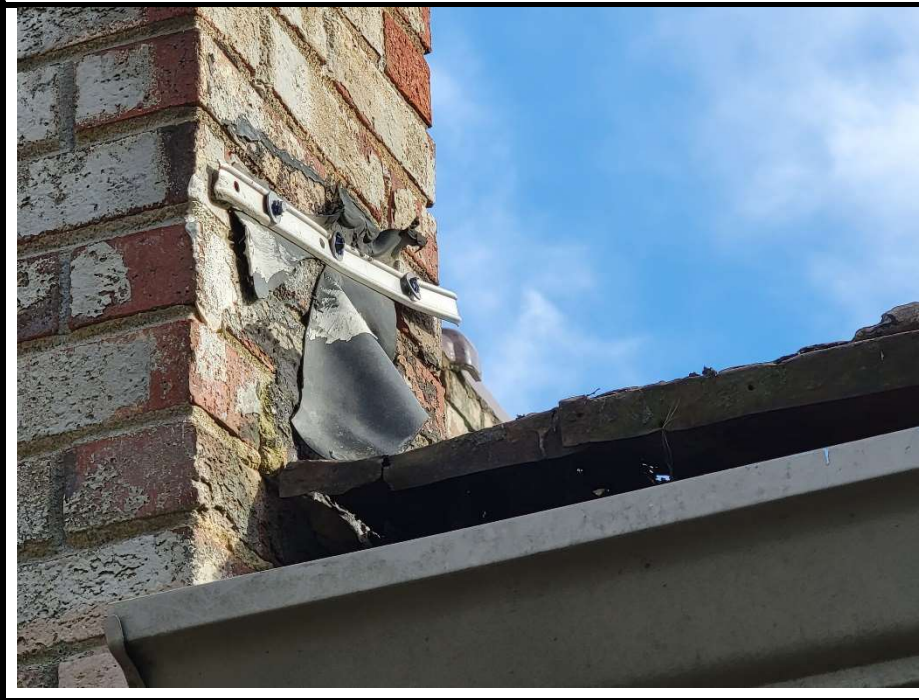
24. 236 & 240 Roof – **ACM**  
**Flashing Caulking**

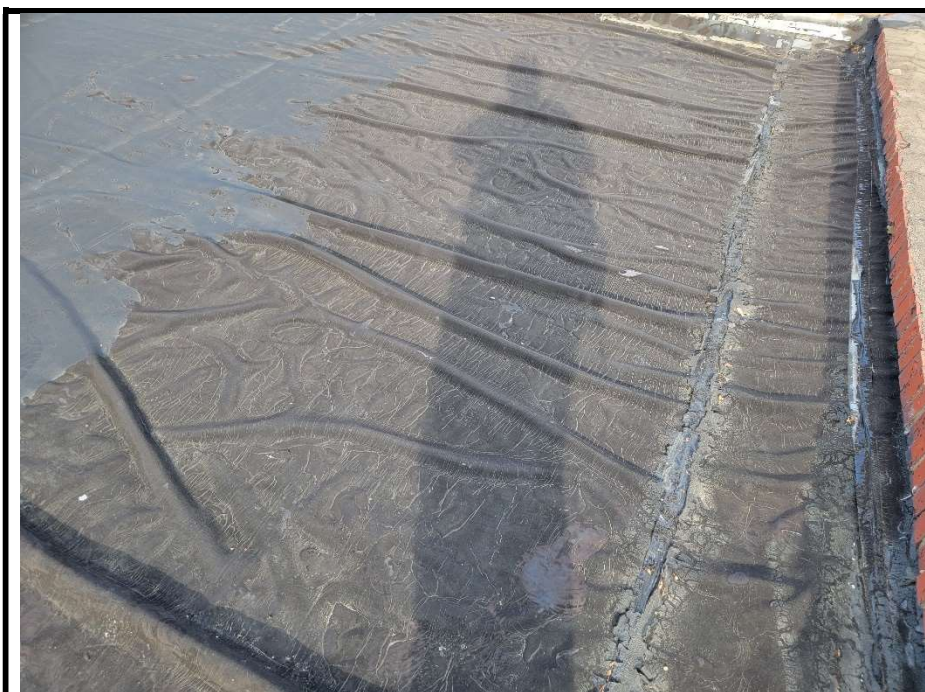
25. 234 Roof Membrane –  
Non-ACM Black  
Asphalt Mastic

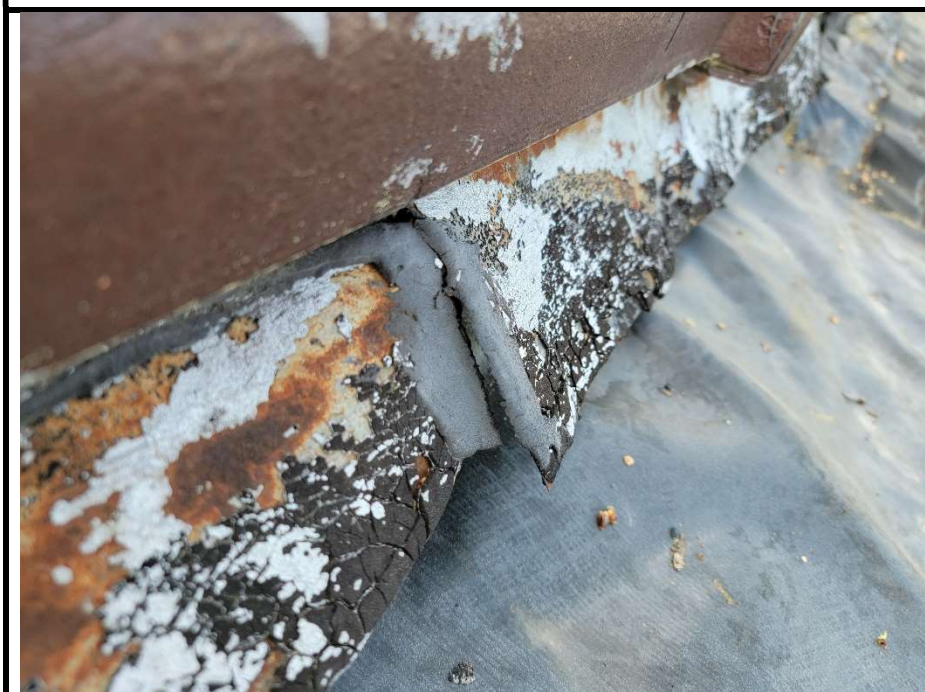
26. 234 Roof – **ACM**  
**Silver/Aluminum Paint**  
at Parapet

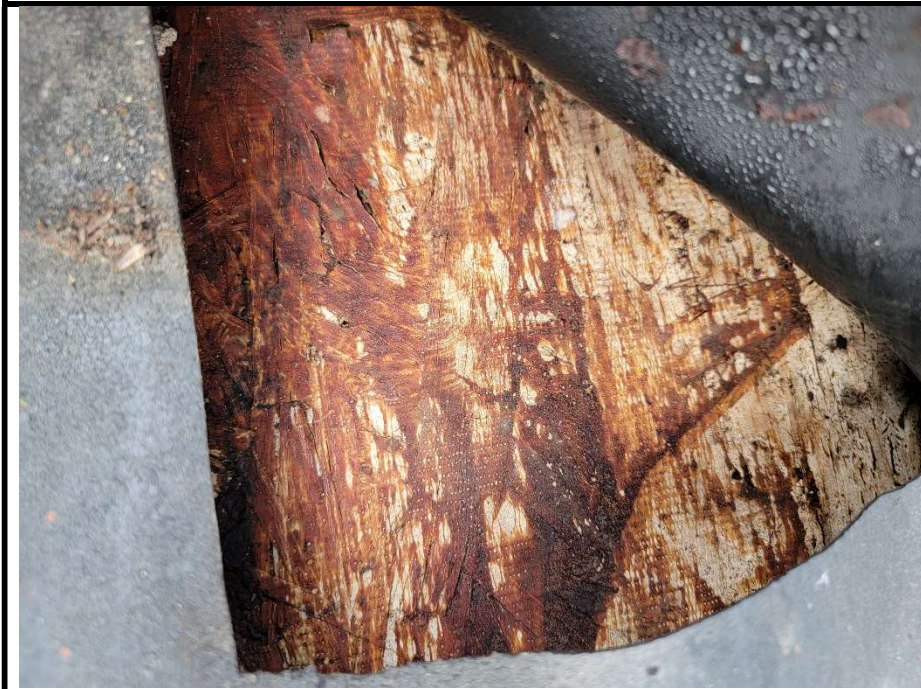
\*\*As 234 is still an occupied space, the decision was made not to puncture the lower membrane layer to inspect what materials may lay beneath them.

27. 234 Roof – Assumed  
ACM White  
Membrane and  
materials below

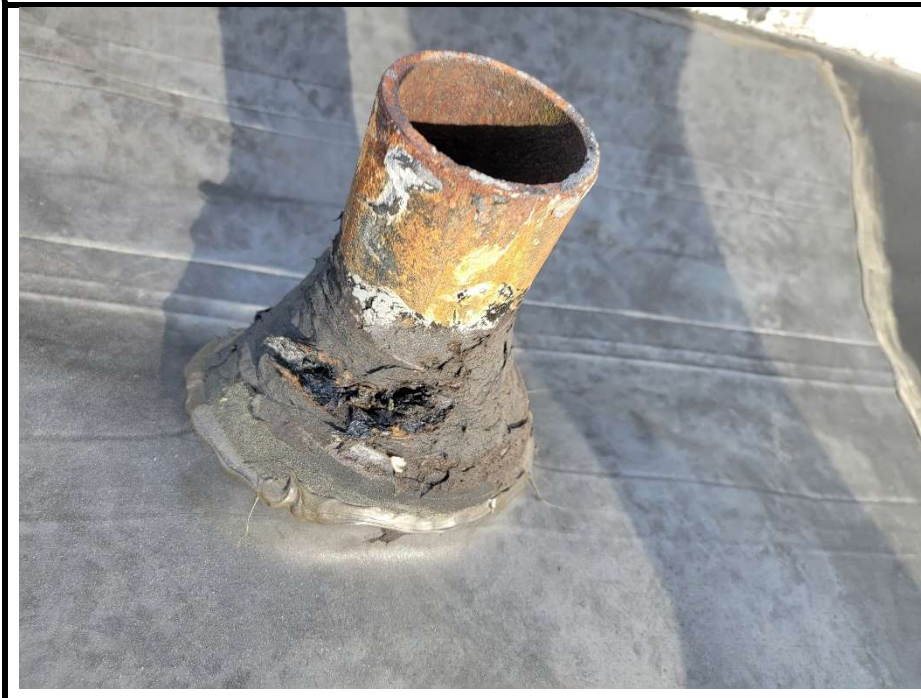
28. 234 Roof – Non-ACM  
Black Asphalt Mastic  
at Intrusions

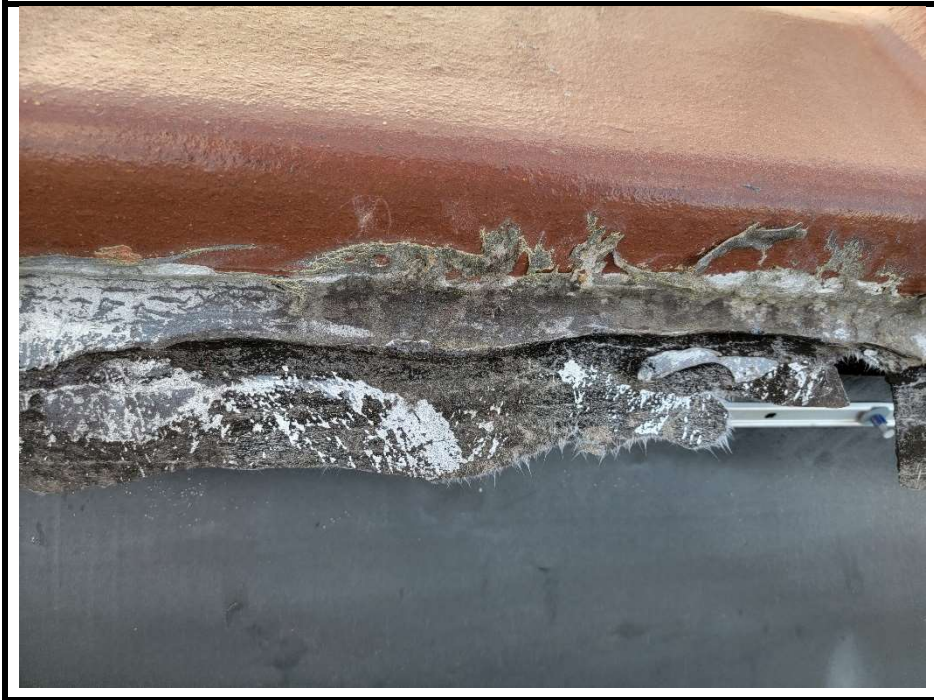
Black Tar	234 Roof at Parapet	5% Chrysotile	140 SF	Damaged	CAT I NF ACM
Black/Gray Caulking	234 Roof Front Parapet	15% Chrysotile	20 SF	Damaged	CAT I NF ACM
Roofing Materials beneath Black Membrane Roofing	234 Roof	Assumed ACM**	1,200 SF	Unknown	CAT I NF ACM

29. 234 Roof – ACM  
Silver/Gray Caulking at  
Front Parapet
