RE: Asbestos Inspection and Bulk Sampling at: 228 McGill Avenue NW, Concord, NC 28025 OSE Job #S23-1011

One Source Environmental, LLC (OSE) was retained by The City of Concord (Client) to perform an asbestos inspection of suspect asbestos-containing materials prior to demolition at 228 McGill Avenue NW in Concord, North Carolina.

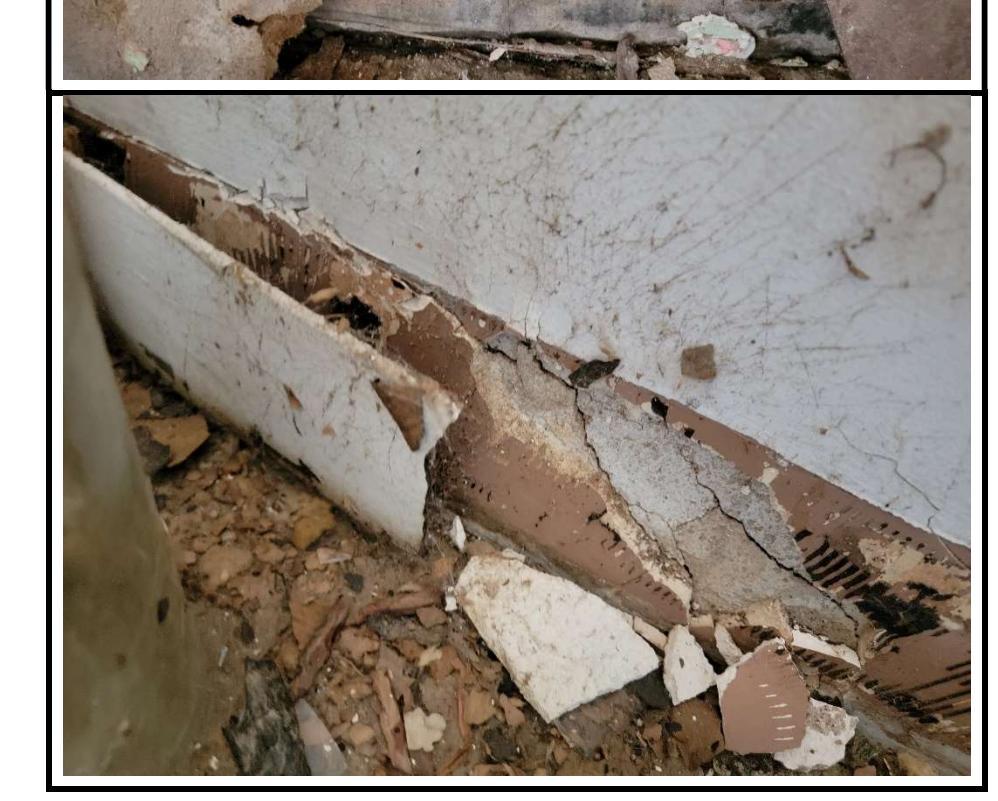
2. ACM 3" Cove Baseboard and ACM Brown Mastic

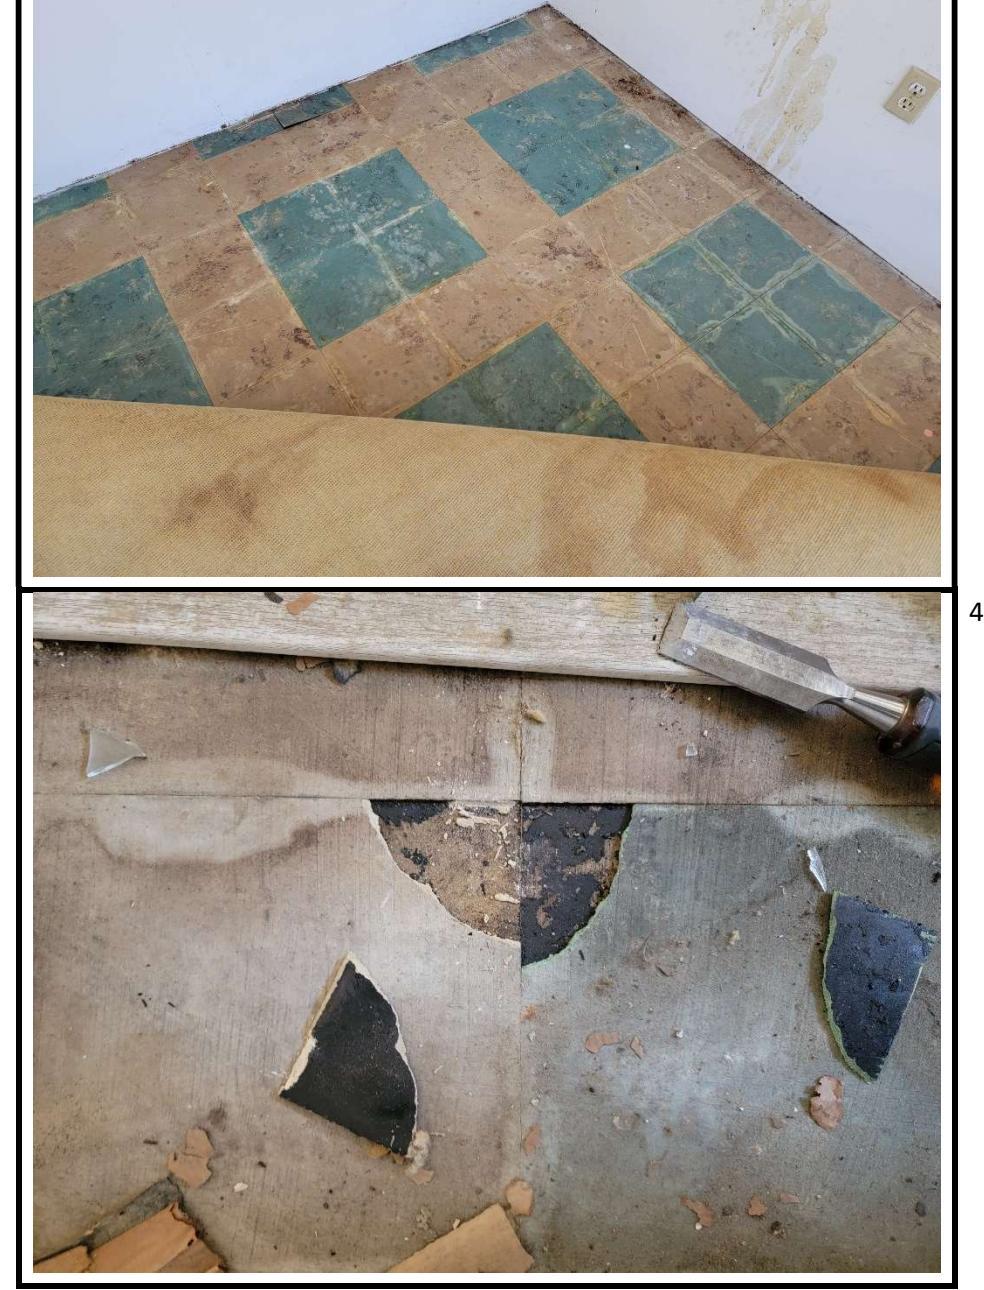
5. Non-ACM Brown Carpet Mastic

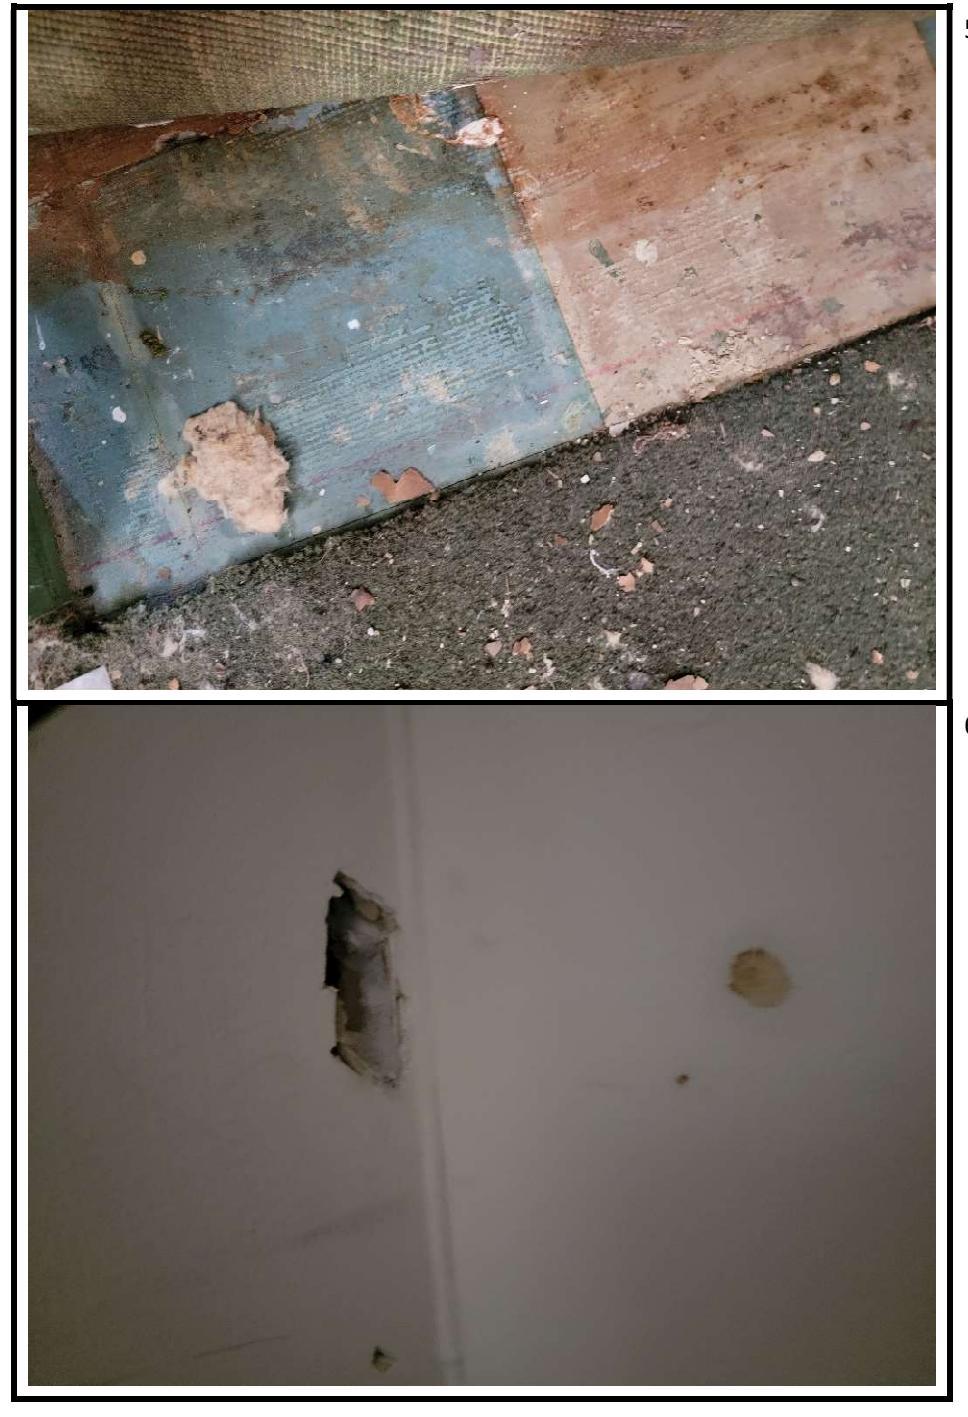
6. Non-ACM Drywall (new)/Non-ACM Joint Compound (new)

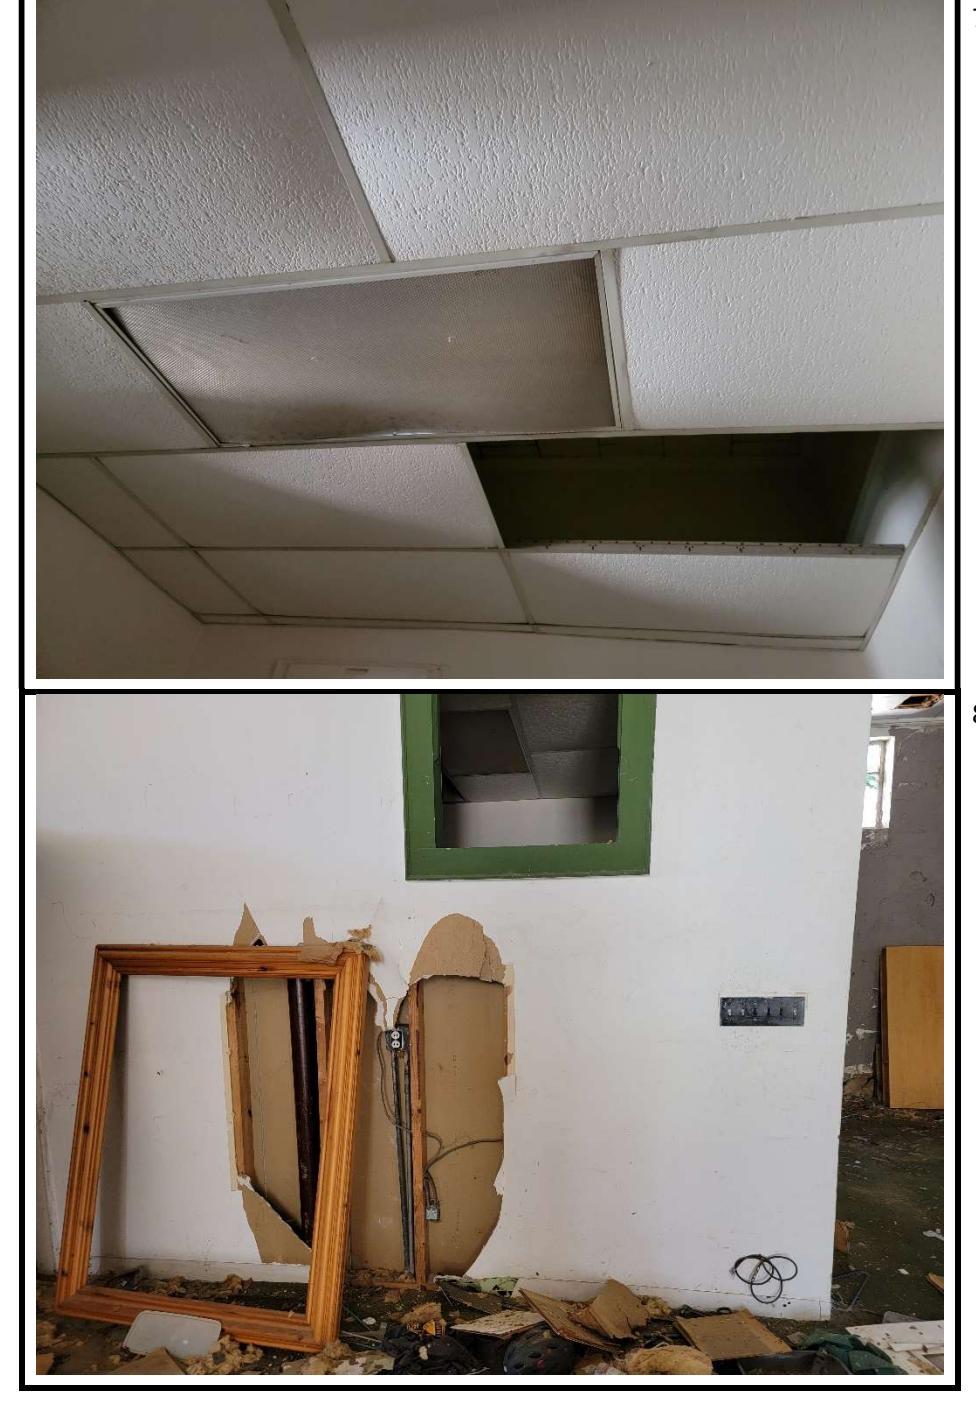
8. Non-ACM Drywall (original)/ACM Joint Compound (original)

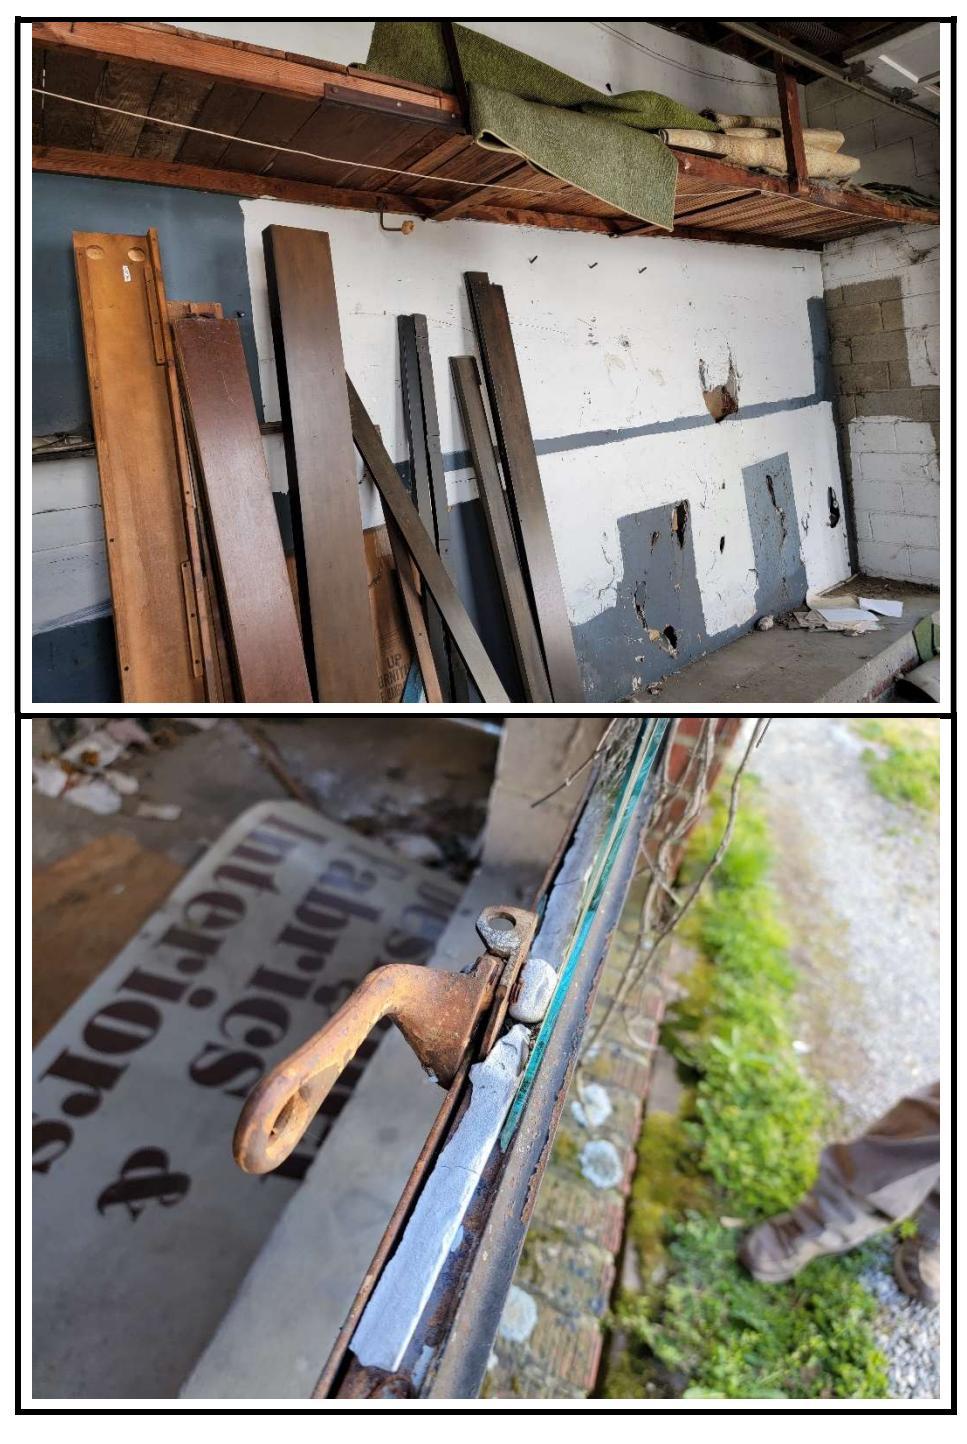
10. Non-ACM Window Glazing Putty
